**Final Report**

**Project No. A-3363**

## **TAC LOADER DOOR REDESIGN**

**Warner Robins Air Logistics Center  
Robins Air Force Base, Georgia**

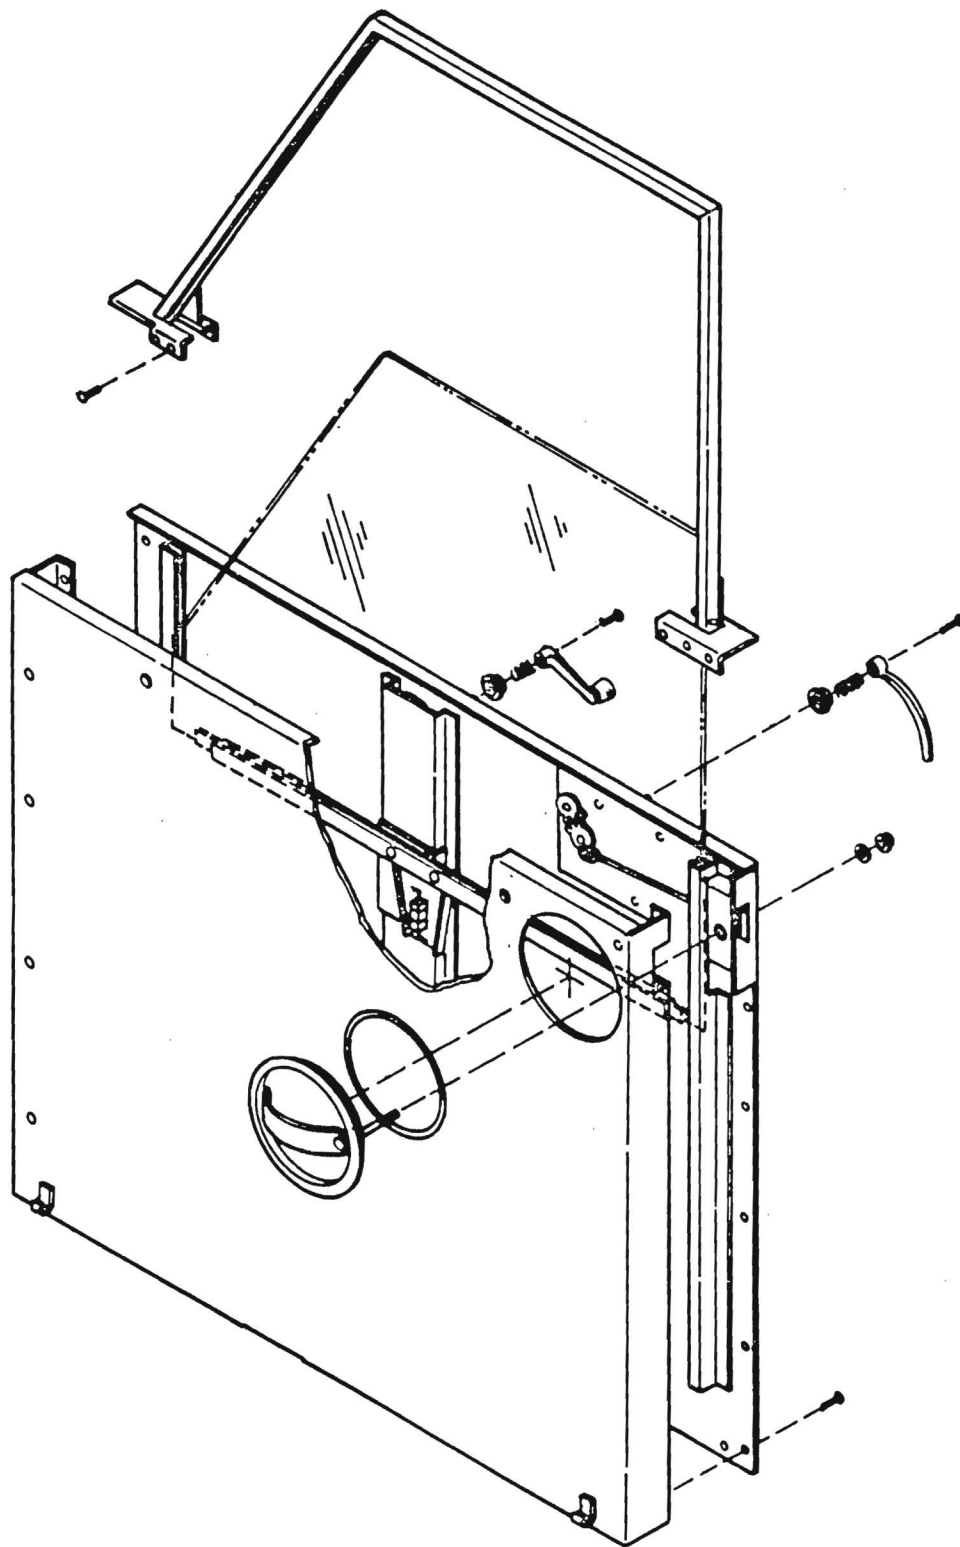
Figure 2. LOADER CAB DOOR ASSEMBLY

The cab door, illustrated in Figure 2, consists primarily of two sheet metal panels, a window rim attached with screws, the window glass, window operating mechanism, and the handle/latch mechanism.

- Severe cracking of the window frame, glass run and supports, resulting in loss or breakage of the glass.
- Loss of fasteners intended to retain major components of the door, resulting in extreme loss of rigidity.
- Failure of the hinge and hinge fasteners to maintain

The lack of a continuous door frame severely limits the structural rigidity which can be attained. The design assumes that rigidity is derived from the components being securely fastened to form a shell. The two door panels are held together with screws, many of which were found to be missing, possibly due to vibration. Many of the threaded inserts which anchor these screws fail or pull out of their mounting points.

Misalignment of the door causes substantial wear and impact damage to the edges of the door and the surrounding cab panels. The misalignment is caused both by radial and axial wear in the hinge and by looseness in the hinge-to-door and hinge-to-cab mounting points. The fasteners at these mounting points are being subjected to local stresses which exceed their capacity.

Three of the four radii on the window frame bracket and gusset were approximately 40% less than the design specification. Bends on the door panels were approximately 20% sharper than specified. Other bends were measured at very near the specified radii.

1. Fasteners must be improved. The hinge is attached to the door and the cab with pop rivets -- a fastener type which is not suitable for supporting significant shear loads. Pop rivets are also used to attach many of the minor components to the door panels. Screwed fasteners which hold the door panels together are anchored with pop-in threaded inserts. These inserts are not secure. They rotate in place, preventing adequate tightening of the screws, while they will pull out completely if significant loads are applied. Two recommended methods are the use of

2. The quality of the hinge itself must be improved. Several hinge types are in use, most of which employ light weight alloys which are not heat treated. The added weight of a steel hinge may well be rewarded with improved performance.

3. The window guides and lift mechanism are not adequate to maintain proper orientation of the glass. As a minimum, the lift mechanism should be replaced with one which provides two separated lift points rather than the current single point.

4. The outside door handle and handle cup are not securely attached. Adequate provisions for holding the cup in place will improve performance.
5. The bend radii on the door panels should be increased to match the acceptable applications for the alloy used. These increases should appear not only in the drawings, but more importantly in the actual fabrication.

6. The window frame should be an integral part of the door. This may not be possible in a limited redesign, in which case a much more secure means of attaching the removable
